NASA CR-120980  
BAC Report No. 8654-953003

## NONDESTRUCTIVE TESTS OF REGENERATIVE CHAMBERS

G. A. MALONE  
R. STAUFFIS  
R. WOOD

NATIONAL AERONAUTICS AND SPACE ADMINISTRATION  
JULY 1972

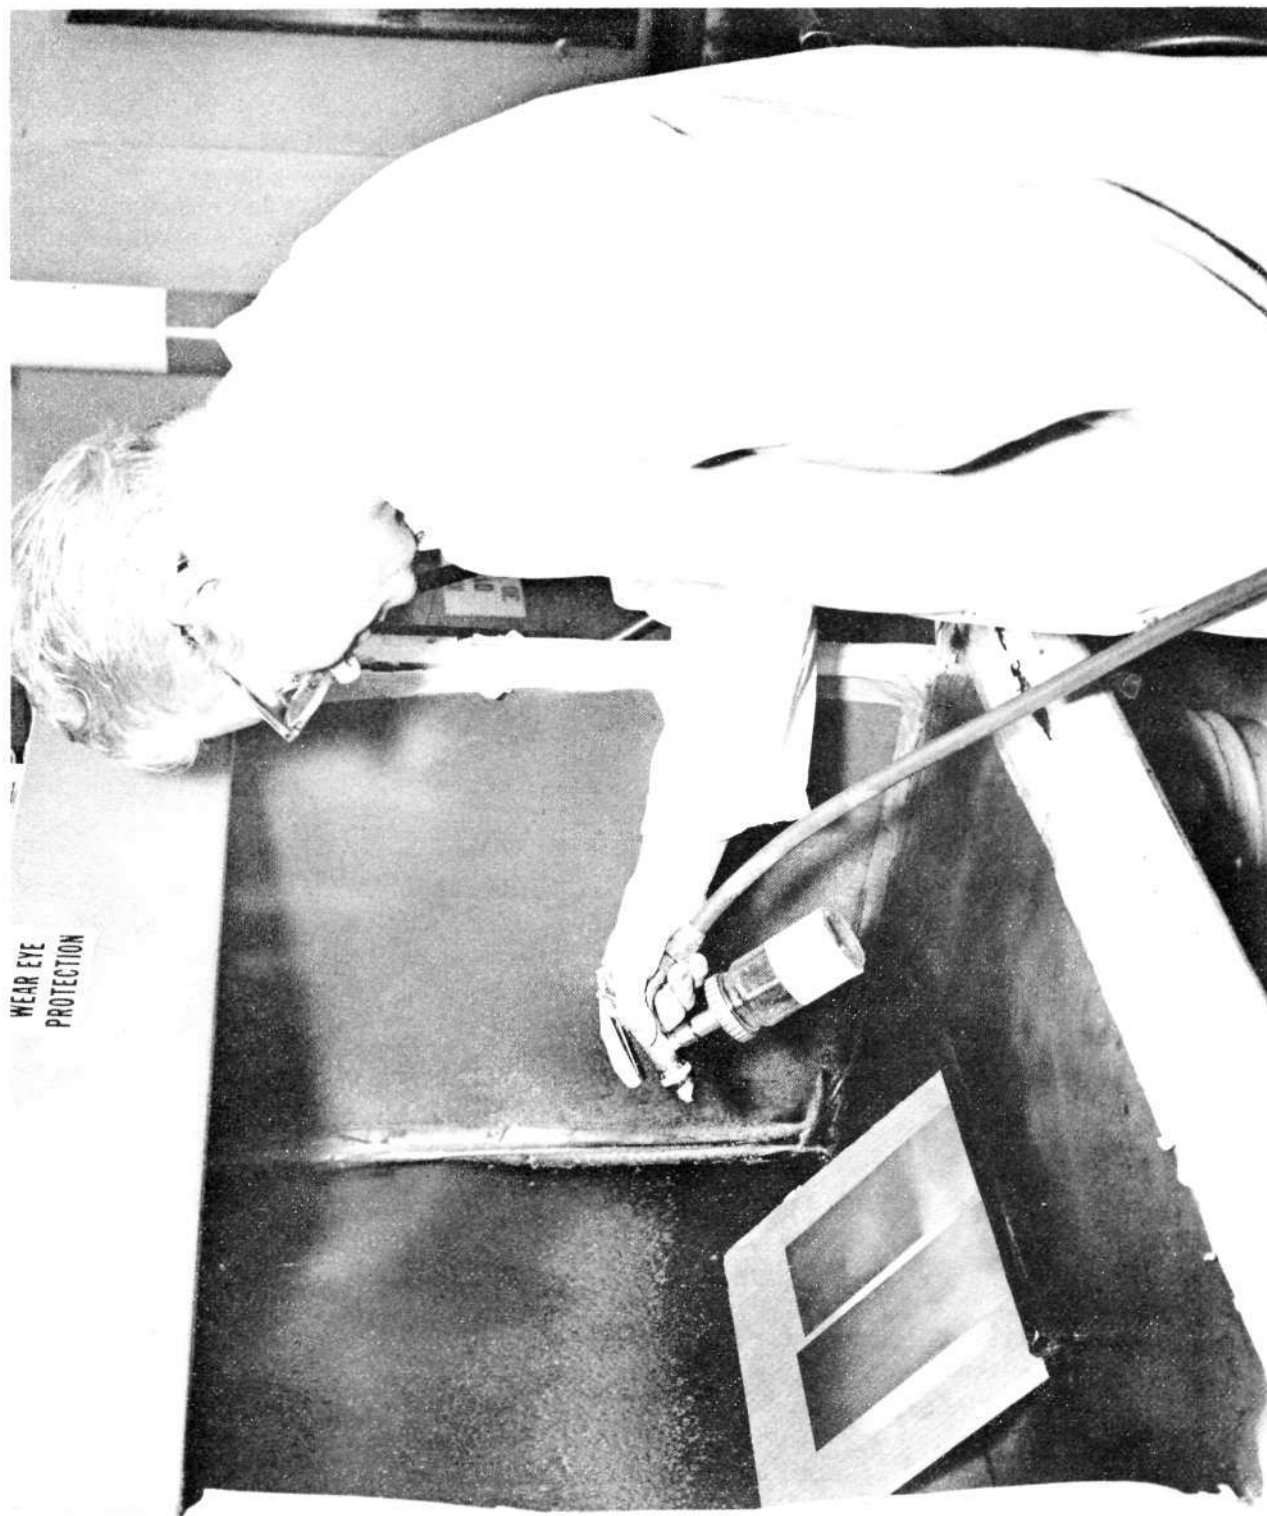
Figure 22. Coating Braze Foil with Photoresist for Photofabrication of Bond Patterns

Copper foil of 0.003 inch ( $7.62 \times 10^{-5}$  m.) thickness was cut to the Nickel 200 plate size and brazed successfully. To produce the defect patterns, the copper foil was coated with a commercial photoresist compound and cured. Photomasters of the defect patterns for weak bond and non-bond were applied over the photoresist and exposed. Chemical etching was used to remove the unprotected copper and the pattern was produced. The remaining photoresist compound was removed with solvent.

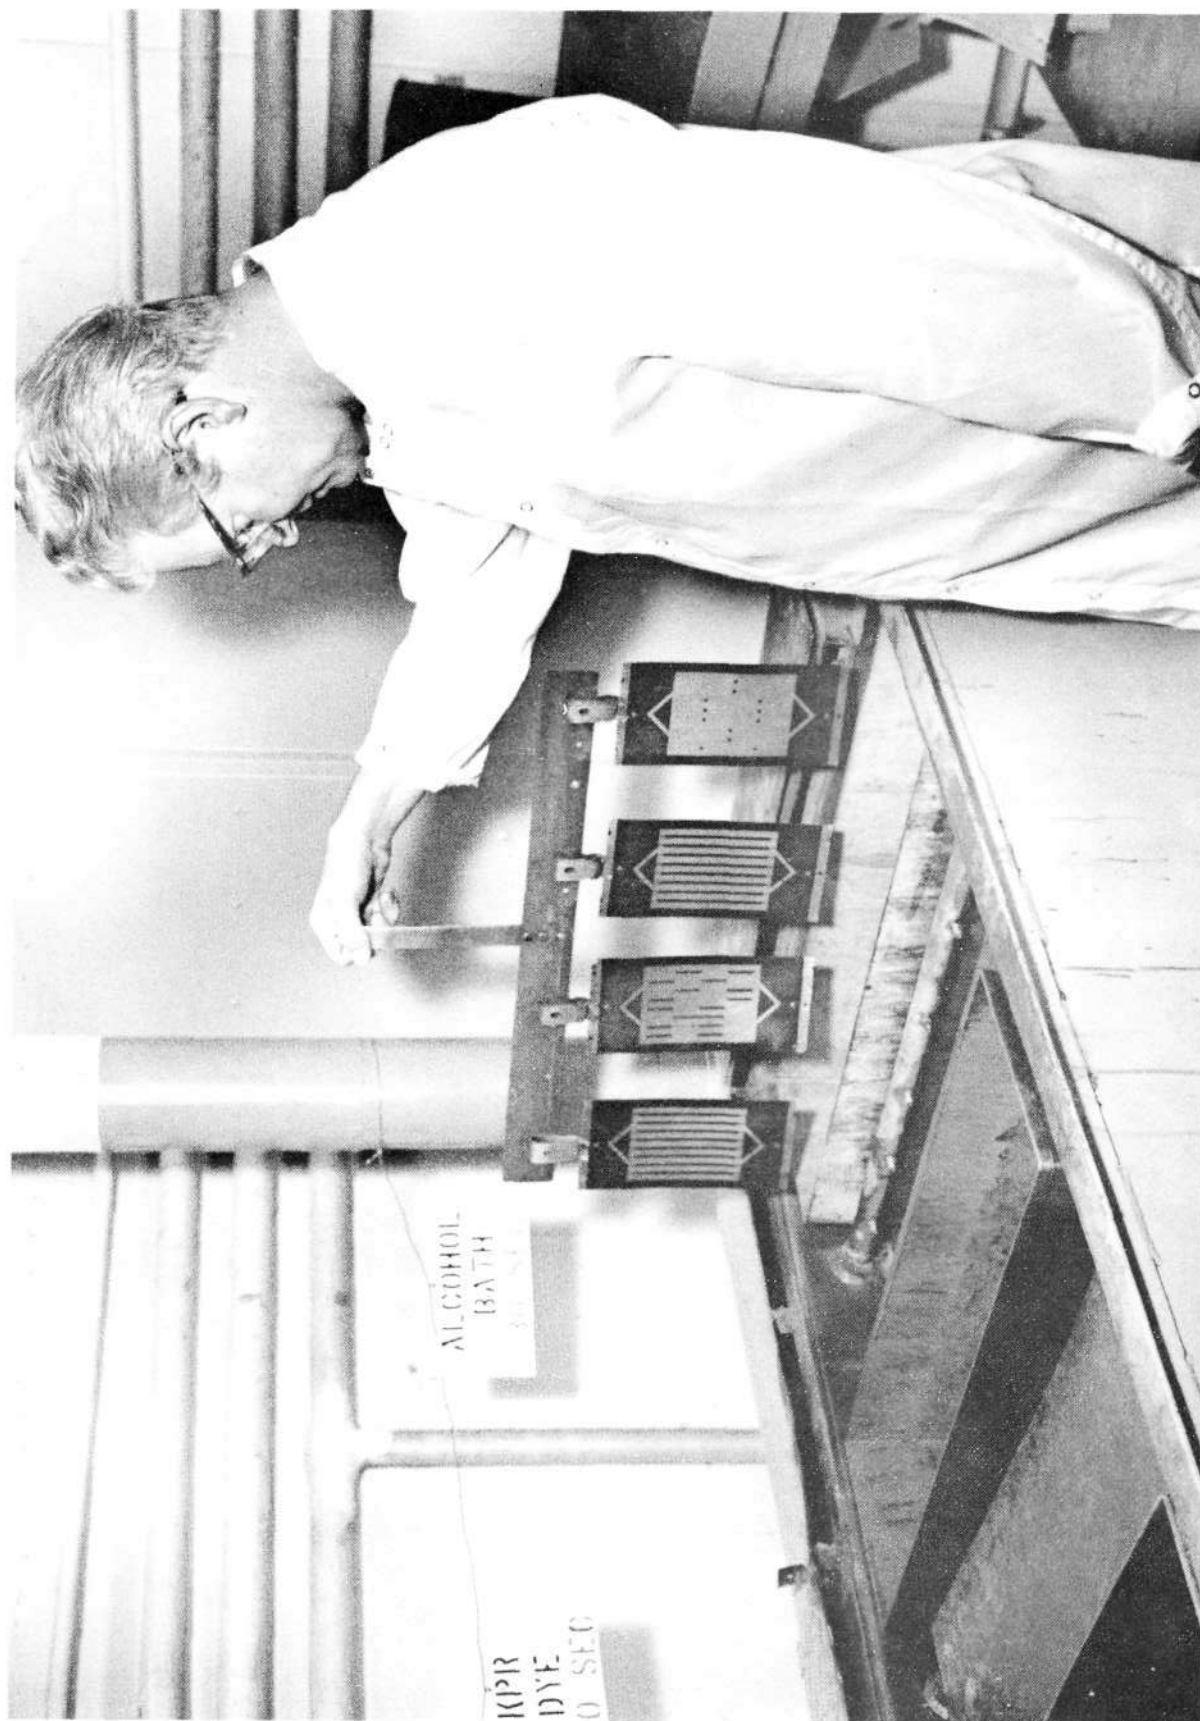
Figure 24. Development of Photoresist Bond Patterns for Brazing

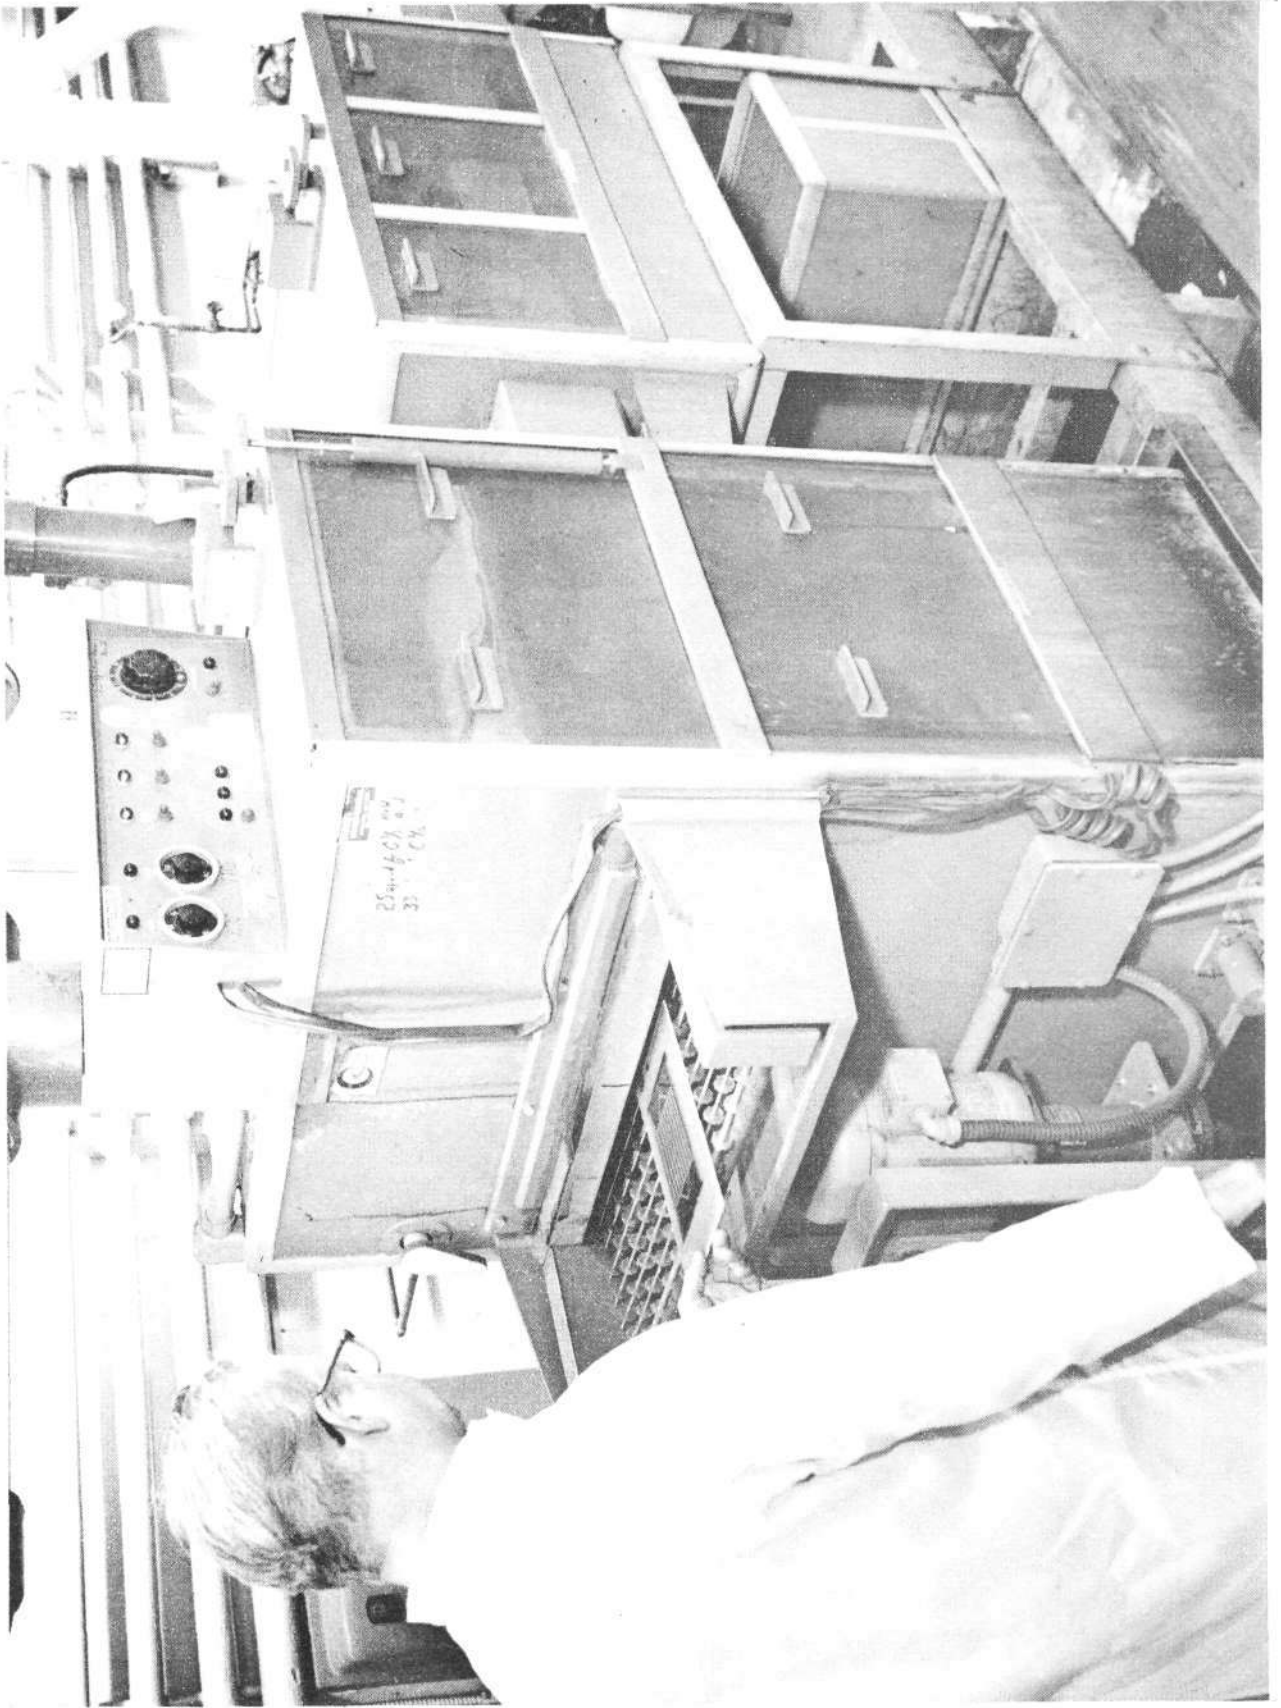
Figure 25. Chemical Etching of Braze Foil Bond Flow Patterns

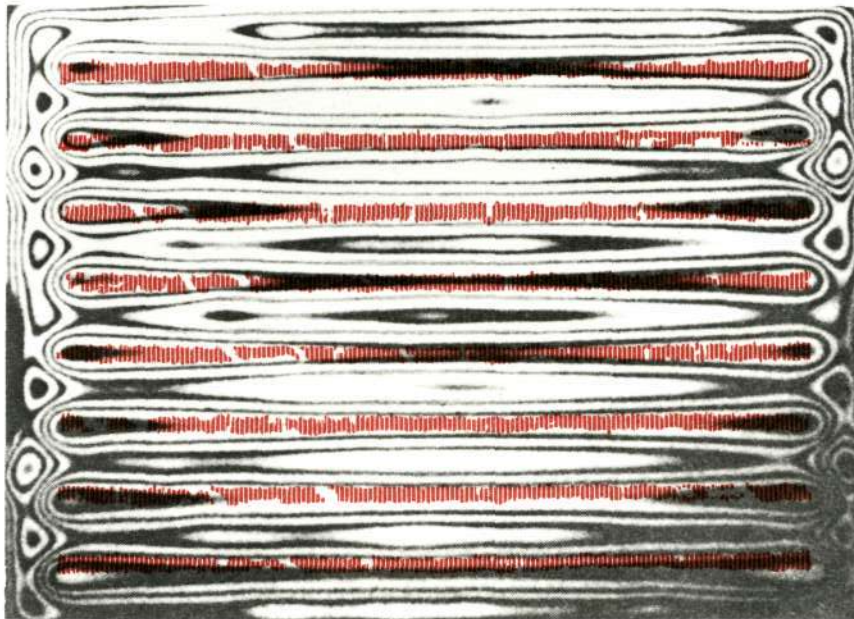
Figure 49

OVERLAY OF ULTRASONIC RESULT ON  
HOLOGRAM FOR PANEL 13E

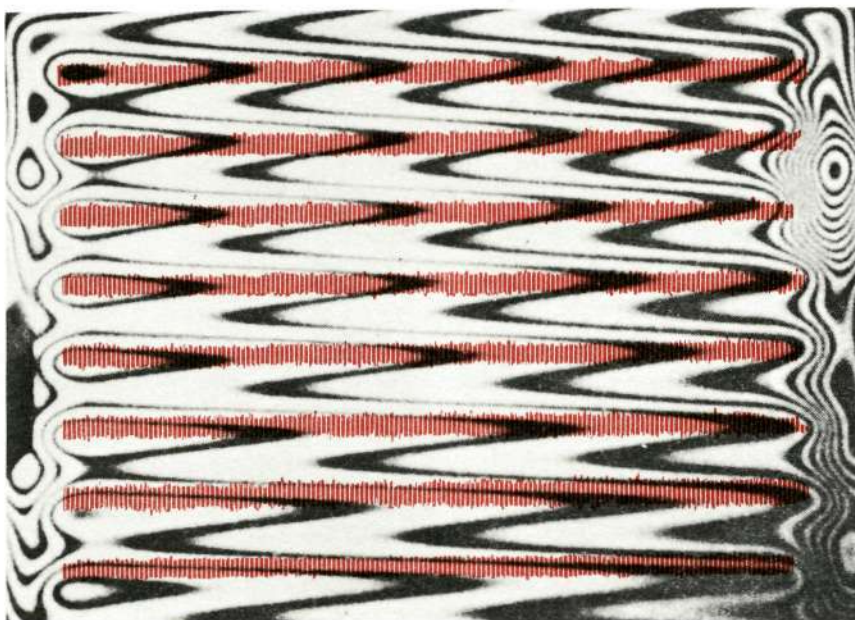
Figure 51

OVERLAY OF ULTRASONIC RESULT ON HOLOGRAM  
FOR PANEL 21B

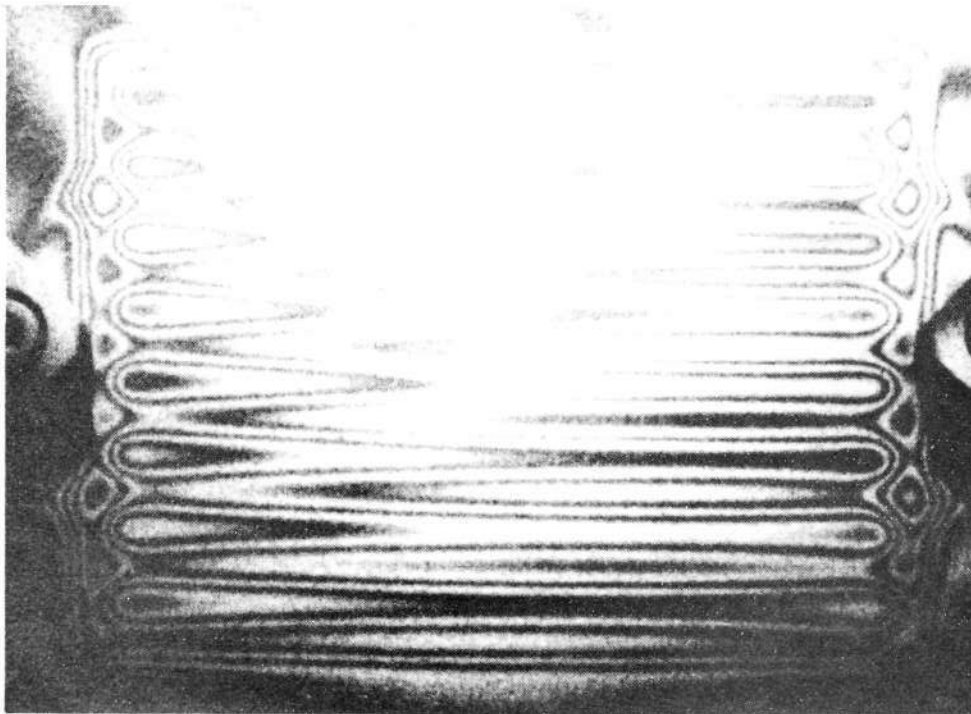
BEFORE GRINDING 500 PSI  
500 PSI ( $3.45 \times 10^6 \text{ N/m}^2$ )

AFTER GRINDING FLAT 500 PSI  
500 PSI ( $3.45 \times 10^6 \text{ N/m}^2$ )

PANEL 10. EFFECT OF FLATNESS ON HOLOGRAM

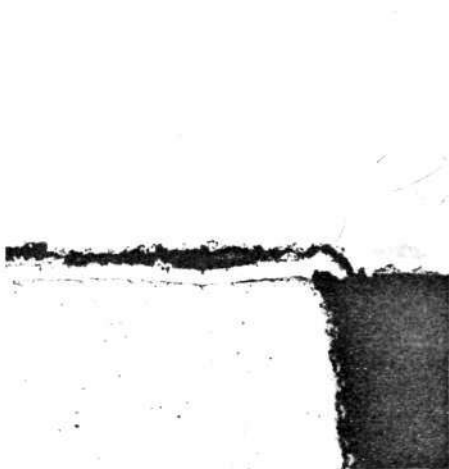
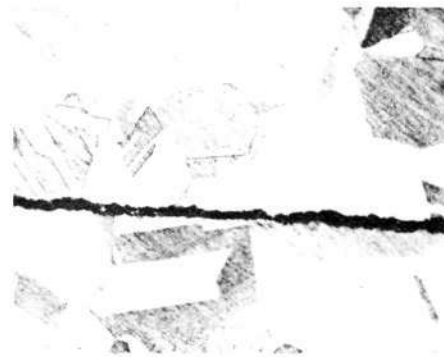
Figure 102. Photomicrographs of Electroformed-Thermally Diffused Test Panels

Failure of bond line in "full bond" panel after exposure to 1800°F (1255°K) and subsequent pressurization - below 1000 psig ( $6.89 \times 10^6$  N/m.<sup>2</sup>). (Magnification 100X, Reduced.)

Lamination occurring at electroform restart after exposure to 1800°F (1255°K). This condition existed below each blister observed after thermal treatment. (Magnification 100X, Reduced.)
